SILVER CREEK DAM

NDS ID NO. PA-00665  
DER ID NO. 54-23

PHASE I INSPECTION REPORT

PHASE I INSPECTION REPORT  
NATIONAL DAM INSPECTION PROGRAM

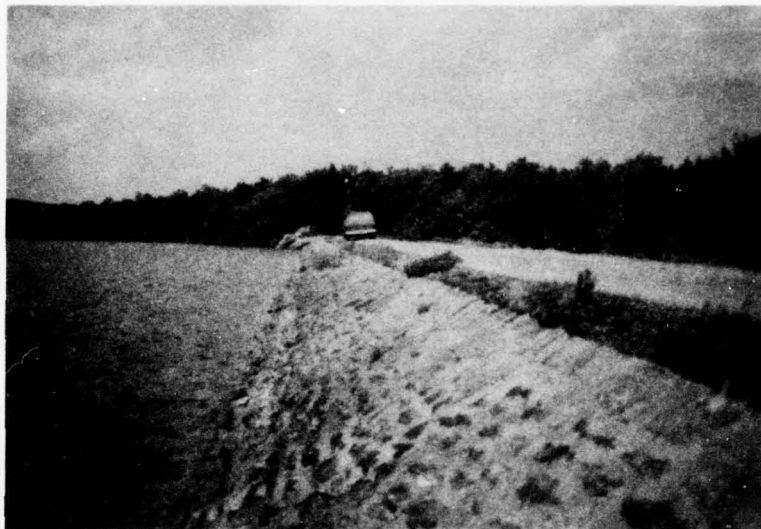
(2) The mortar between the riprap on the upstream slope was cracked along the water line (Photograph A). Near the left abutment, the cracking was accompanied by differential movement of up to 3 inches and by displacement of some of the stones (Photograph D). At other areas, the riprap was intact and in good condition (Photograph A). The slush-grouted riprap ends about 100 feet from the right abutment. The riprap beyond the grouted riprap is intact, but it is overgrown with ferns and light brush (Photograph C). The Owner said that the cause of the damage to the riprap on the upstream slope is ice.

(2) The cracking of the mortar between the riprap along the water line is a condition that will cause progressive deterioration of the slope protection. At the areas where the differential movement and stone displacement has occurred, the deterioration has already progressed to the extent of being unsatisfactory. At the right end of the dam where the riprap is not grouted, there were no signs of unsatisfactory performance. However, the growth of brush among the riprap is undesirable.

A. Upstream Slope of Embankment.  
View Toward Left Abutment.

(1) Repair damaged riprap on upstream slope.

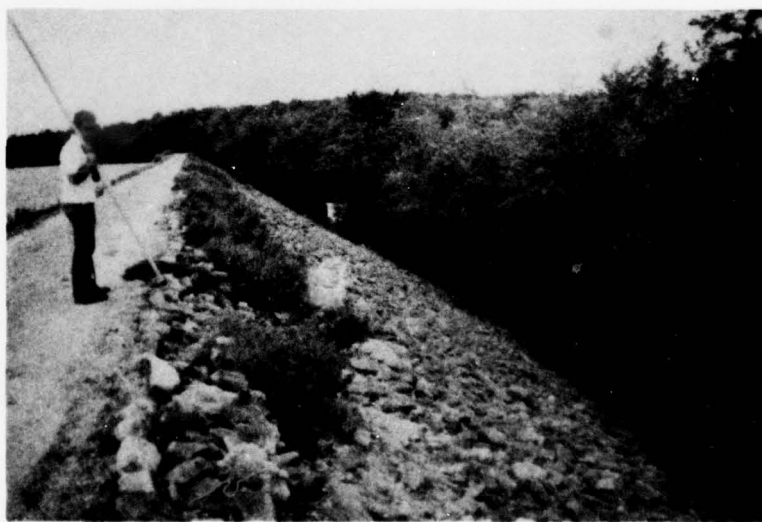
(3) The riprap on the downstream slope of the embankment was generally in good condition except that light brush was growing in some areas (Photograph B).

B. Downstream Slope of Embankment.  
View Toward Left Abutment.

(2) Remove brush from embankment slopes and spillway channel.

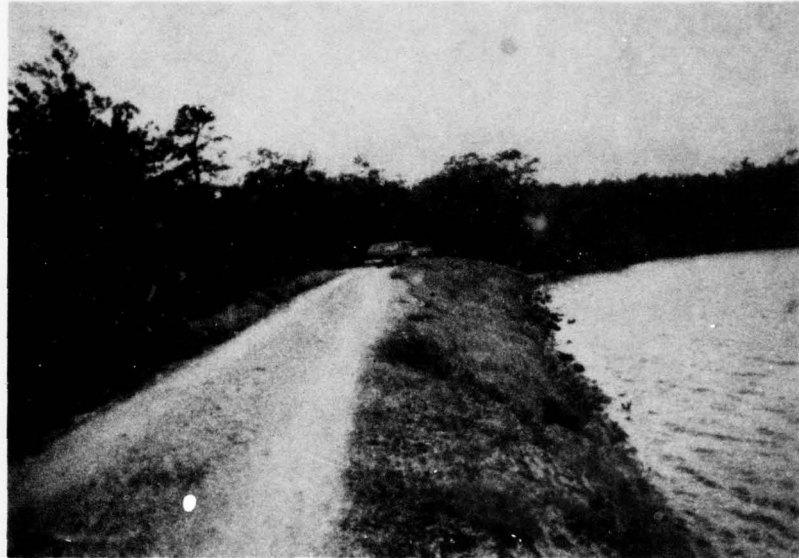
C. Right Abutment Area.

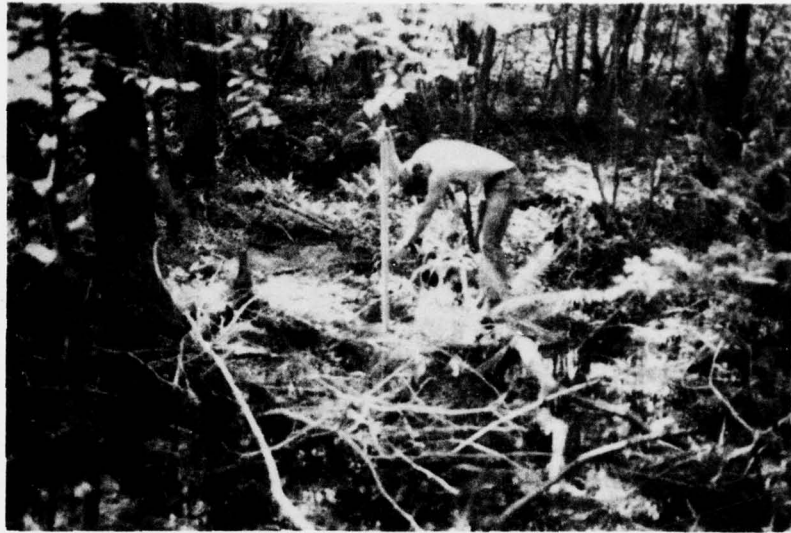
(4) The eight wet areas that were observed during this inspection are of concern. Research of records of previous inspections indicates that the first seepage developed about 1927, at which time the dam was 77 years old. The first seepage that developed was along the toe of the embankment to the right of the gatehouse. Apparently, seepage was first observed to the left of the gatehouse about 1933. Because detailed descriptions of the character and quantity of seepage are not available, it is not possible to determine to what extent the problem has increased. Inspections performed after 1933 indicate that the seepage continued, but the descriptions are somewhat sketchy. It appears that the conditions observed in this inspection are essentially similar to those observed in previous years. However, almost nothing is known about the design or construction of the dam. Consequently, the possible effects of the seepage are difficult to evaluate. During this inspection, three of the eight wet areas appeared to have accumulations of fine soil at their outlets. Although all the flow was clear at the time of the inspection, there might have been some migration of embankment materials in the recent past. The age of the dam, which is 128 years, the lack of information concerning its design and construction, and the extent and character of the seepage combine to create a situation that is of special concern.

E. Wet Area No. 2.

(2) Clear the area along the downstream toe of the embankment and identify all seepage outlets. Construct a system of channels and weirs so that flow measurements can be made for all seepage points and so that any accumulation of soils that might be coming from the embankment can be recognized. Monitor and record data so that any change in conditions is readily apparent.

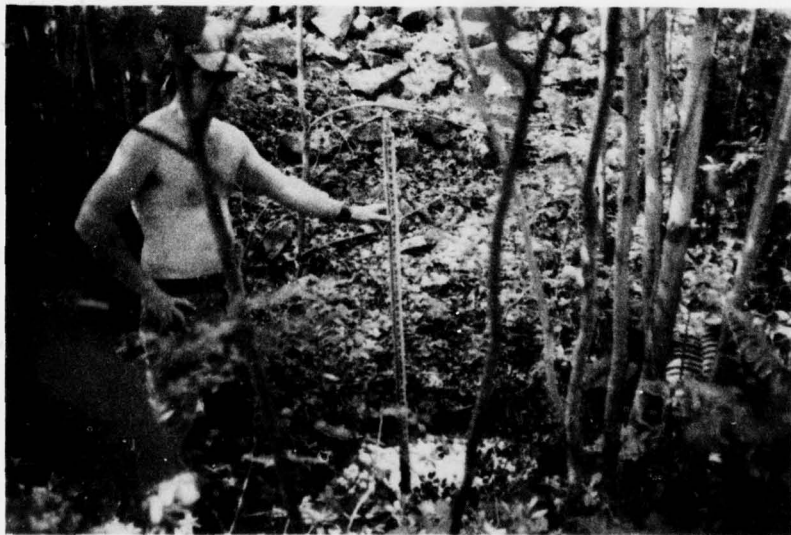
F. Wet Area No. 4.

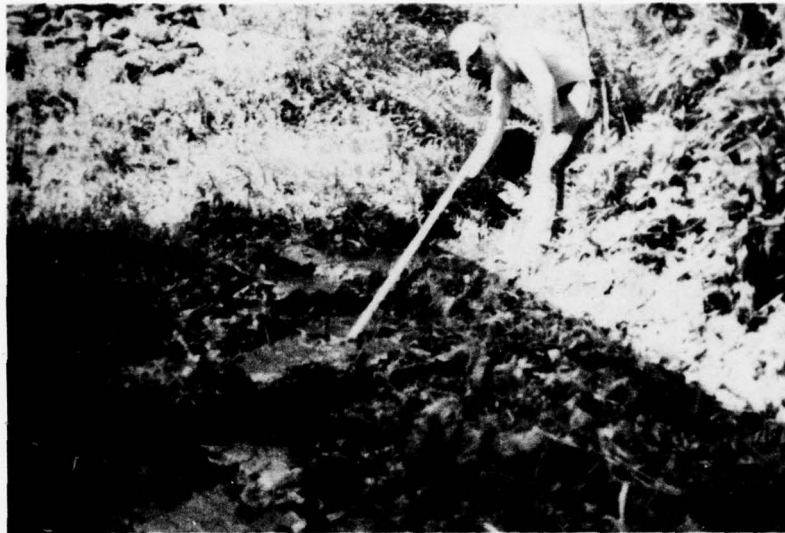
G. Wet Area No. 6.

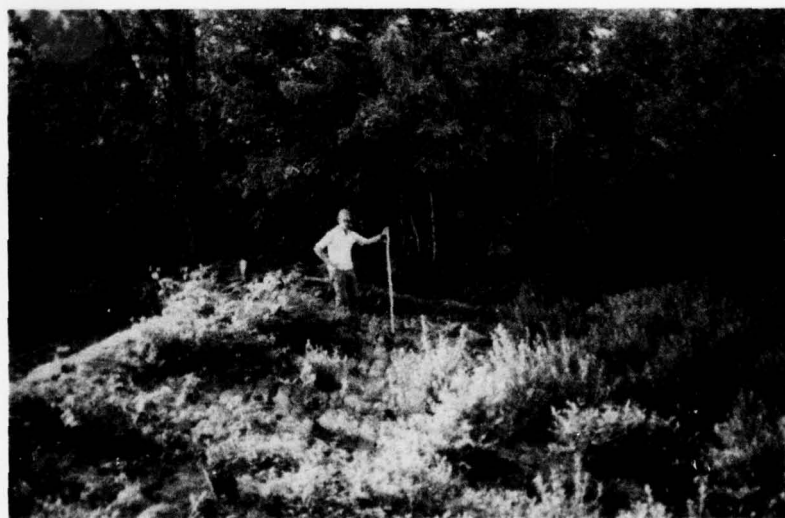
(1) Spillway. The concrete spillway weir was in poor condition. The concrete was cracked at intervals of 3 to 4 feet, and a 3-foot long section was missing near the left end. Light brush was growing in portions of the stone-lined channel, and all of the unlined channel was overgrown with 3-foot high brush (Photograph H). It was also observed that significant flow across the overbanks would occur on both sides of the spillway before the dam would be overtopped.

H. Spillway.

(3) Repair concrete on spillway weir.
